A Soil Suitability/Land Use Analysis of the Historic Ketner Dam Basin in Comparison with the Elk County Comprehensive Land Use Plan

Prepared by Christopher Catalano - May 2020

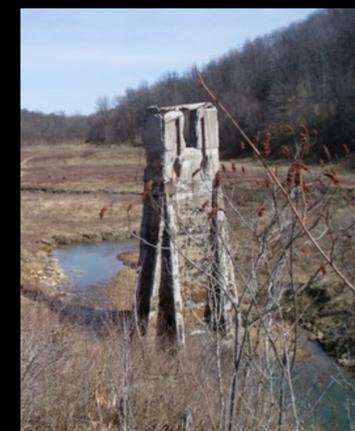
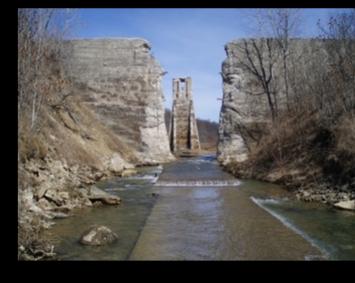
Top: the old gate house control tower, Bottom left: the breastworks blasted out, Bottom right: remains of western spillway.³

The dam, or what is left of it, is located in Glen Hazel, PA (Elk County). Historically, this was the site of a dam constructed to supply water to steam engines hauling lumber over the steep grade in the area. Due to torrential rains during its construction in 1911, the dam was destroyed by blasting a section of the breastworks to alleviate dangerous flood conditions. Today, all that is left are the ruins of the gate tower, spillway, and breastworks, with a stream running through the basin that was once the reservoir.¹

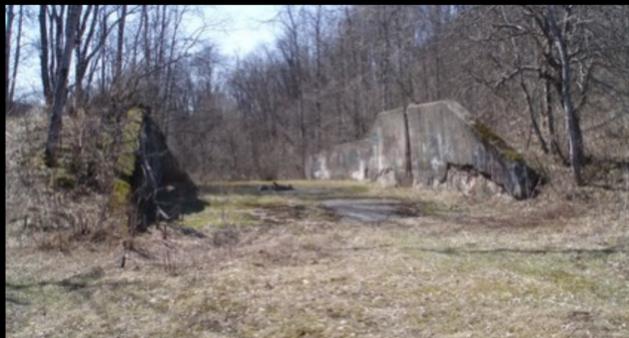
An examination of historic maps from 1940 and 1972 helps us to understand the land use history of the dam area. Little has changed, in that nothing new has been built on or removed from the site. Nature is reclaiming the defunct dam works. The most obvious change is the large gap in the breastworks from the beaching of the dam with explosives. It is of note in these photographs that Johnson Run has apparently changed the location of its stream bed over time. A LIDAR imagery study makes this all the more obvious. The ground of the basin is most likely a layer of unconsolidated sedimentary fluvial deposits laid down in part while the reservoir was filled and then subsequently during occasional flooding cycles. Those soft unconsolidated deposits were then likely cut into by the flow of Johnson Run. A reddish-brown coloration of the stream is noticeable in the color photograph.

Figure 3 (below): View of Ketner Dam on 26 June 1972. The breastworks still had not yet been breached. The central section is visibly intact. The dam was not fully demolished until after a boy drowned in 1979. However, at this point in history the dam had been emptied of all but a small amount of water at the breastworks and around the gate tower. North is up.
